- **Author:** Jesse Zacarias
- **Subject Matter:** Automatic transmission
- **Unit:** AW55-50SN
- **Vehicle Application:** 2002 Volvo S60
- **Issue:** Speed-sensor codes

Testing the Speed Sensors

in the AW55-50SN Transmission

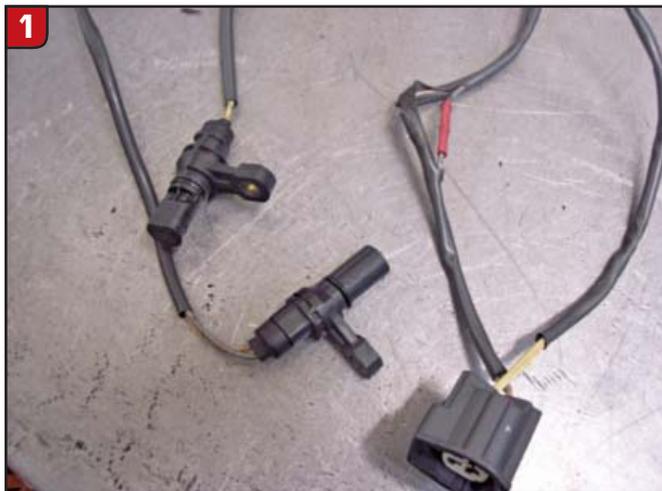
A 2002 Volvo S60 arrived at our shop with two codes in the TCM: 0023 “Transmission input shaft speed sensor signal missing” and 0089 “Transmission input speed sensor, signal too low.” The vehicle was in “limp-home mode,” which allows the transmission to be operated in 3rd and 4th gears only and with high line pressure. The customer had bought the vehicle with these conditions and did not know its history. Visual observation showed that someone had spliced into the speed sensors (**Figure 1**) and had replaced the transmission with a used one.

With the cut wire on the speed-sensor harness and the fact that there is an updated speed-sensor assem-

bly we decided to replace the sensors. The old speed-sensor harness is hardwired onto the speed sensors; the updated harness kit separates the speed sensors from the harness (part # 30713724), making it possible to replace speed sensors in the future without replacing the harness.

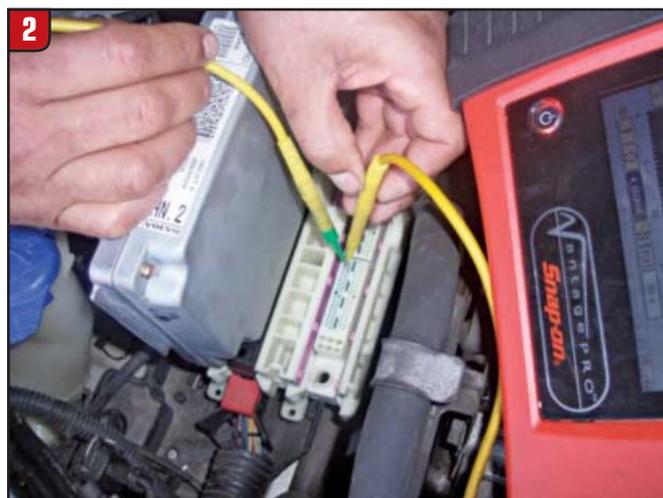
The best way to check the speed sensors is to back-probe the TCM and check for voltage drop, but on a Volvo this is pretty difficult without a break-out box. The next-best thing is to check the resistance of the speed sensors by probing the TCM connector with the TCM removed (**Figure 2**). This method will check the

entire circuit of each speed sensor for open or shorted wires. Pins A41 and A59 will check the ISS circuit, and A57 and A39 will check the output-speed-sensor (OSS) circuit. The reading should be between 3 and 7 megohms for both ISS and OSS, depending on temperature (**Figure 3**). Be sure to use a probe no bigger than 0.026 inch so as to not to open up the female connector, which will cause a faulty connection between the TCM and the harness. If you use a probe bigger than 0.026 inch, then just touch the wire without sticking the probe into the female connector. I have corrected many electrical problems because someone had used the wrong probe and damaged the connectors, causing a bad connection.

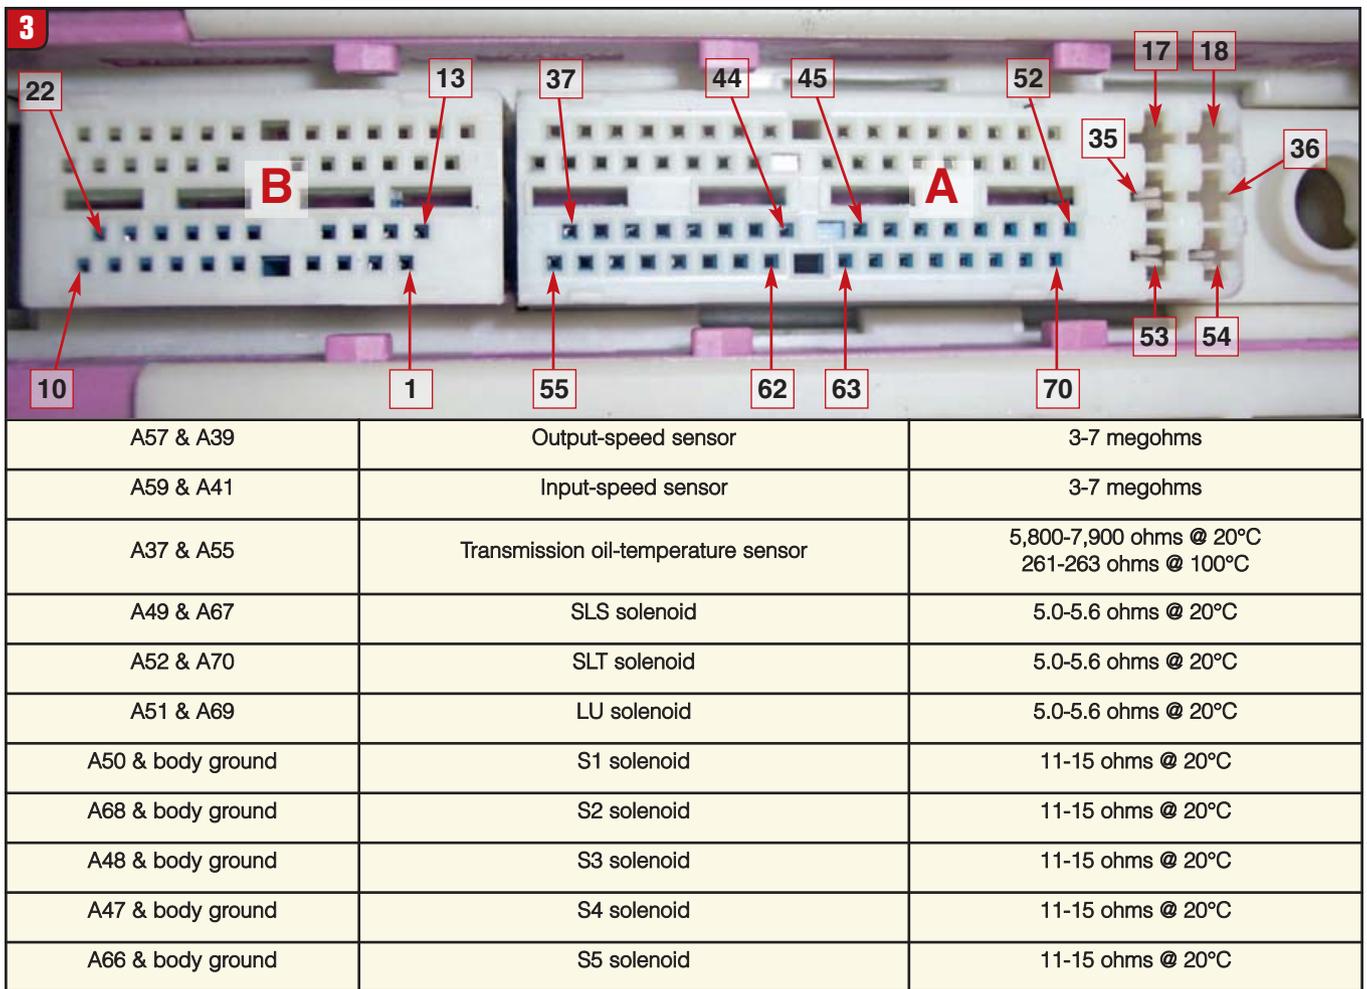
The pin ID we have provided in Figure 3 seems to be the same for all Volvo models that use the AW55-50SN transmission. **TD**

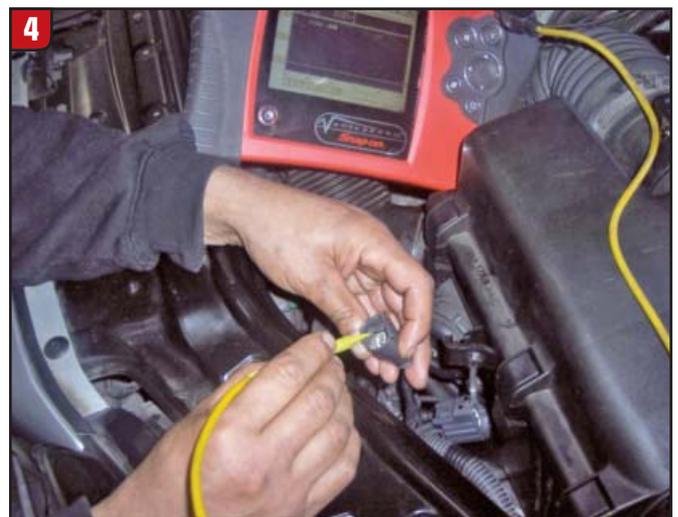
by the TCM to the ISS and OSS. To do this we installed the TCM back into the vehicle, connected the car battery and disconnected harness connector "A," which connects both speed sensors to the TCM. With key on, engine off, you should have anywhere between 7 and 9 volts in pins 2 and 4 (**Figure 4**).

Here we noticed that although pin 4 (OSS) voltage was 7.7, pin 2 (ISS) voltage was only 4.3. When we reconnected the harness, the voltage on the ISS dropped to 1.8 and on the OSS to 7.2. We had already confirmed no opens or shorts to ground on each circuit, so we knew we had a bad TCM. While there we decided to check for a good ground from the TCM to the speed sensors at pins 1 and 3. With harness "A" reconnected and back-probing pins 1 and 3 we had 0.280 millivolt during engine cranking, which proved we had a good ground.

After replacing the TCM we got the voltage to the ISS and OSS restored, and the transmission returned to normal operation.

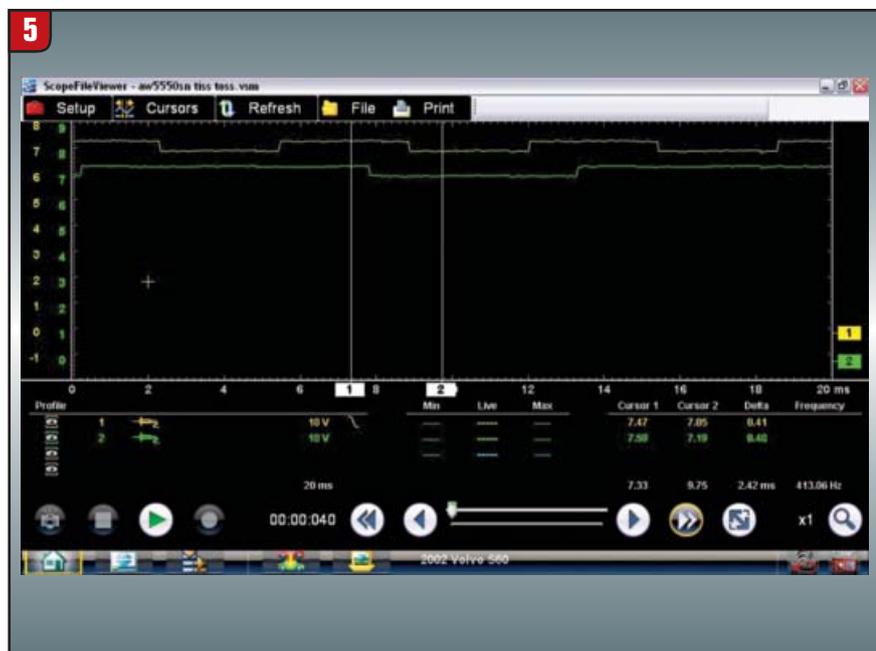
read, so the best thing to do is check the voltage drop at the speed sensor, as the exciter is closer to the magnet of the speed sensor, causing the change of current (Hall effect). In this instance it is between 300 and 400mV (Figure 5).

Figure 5 shows channel 1, yellow tracer, back-probing ISS voltage at pin # 2 of the A connector and channel 2, green tracer, back-probing OSS voltage at pin # 4 of the A connector. The scope is grounded to battery ground. Cursor 1 is where the exciter is farthest from the sensors, and cursor 2 is where it is the closest. The voltage drop remains the same with little change due to temperature change of the speed sensor. The frequency, however, will increase for the ISS as engine speed increases, and for the OSS as vehicle speed increases.
