Lack of power caused by PCM malfunction

4R100

2002 Ford F-550 diesel truck

Causing Loss of Power

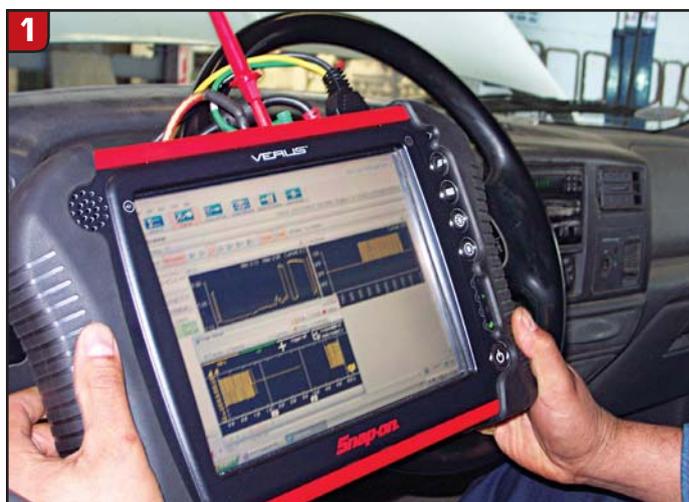
We installed the VERUS™ and monitored the PCM parameters via the scan tool while at the same

time using the scope to monitor the modulation of the pressure-control solenoid by back-probing the PCM at pin 81 (Figure 1).

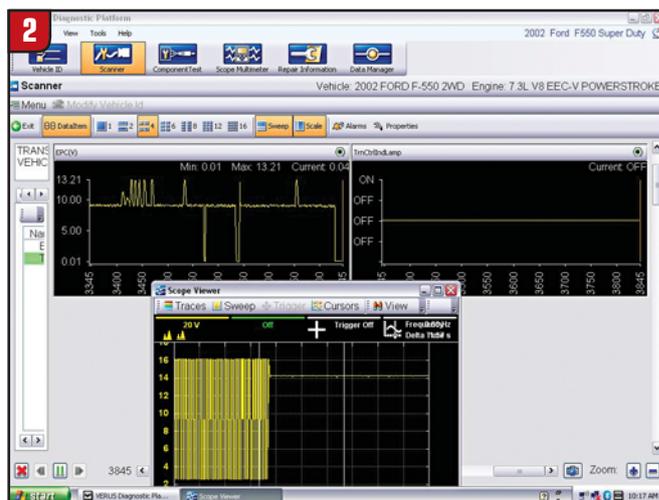
We noticed that the EPC voltage would, at times, drop to 0 and that the PCM would stop modulating the EPC solenoid. At times this would happen so fast that the overdrive light did not flash (Figure 2).

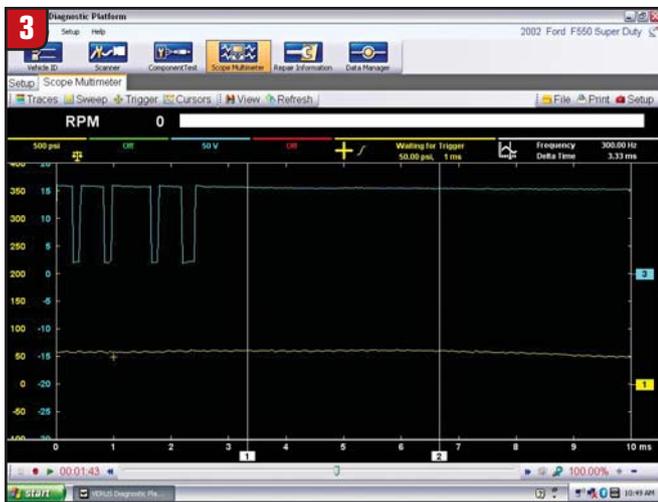
By concentrating on the lab scope and installing a pressure transducer on channel 1, we were able to see EPC modulation on channel 3 and line pressure in channel 1 at the same time (Figure 3).

We noticed that when the PCM stopped modulating the EPC solenoid, the voltage at the PCM at pin 81 would be about battery voltage and the main line pressure would eventually increase to 150 psi.

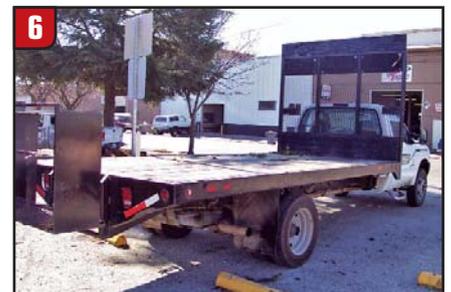
When this particular Ford F-550 (Figure 6) was fully loaded, the vehicle would not be able to make it up the smallest hill in failsafe mode.
