Delayed engagement in reverse, neutralizing during deceleration

5R110W TorqShift

2007 Ford F-450 with 6.0 diesel

# What We Do for a Buck

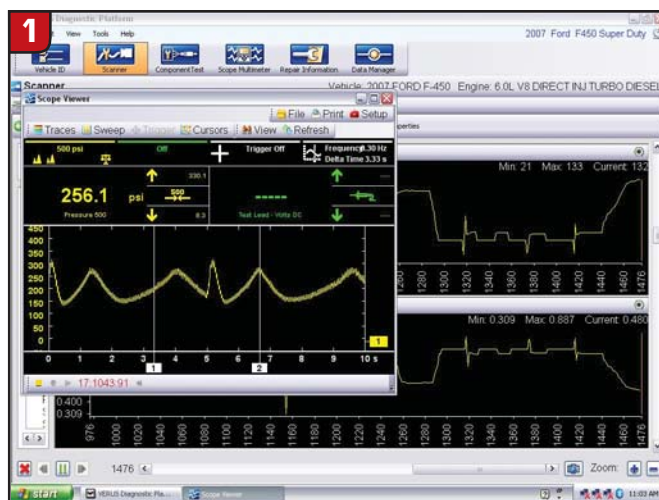
The next step was a stall test, so we brought the engine speed up to 1,500 rpm in reverse and noticed that PC-A

amperage was steady at 0.48 but mainline pressure oscillated from 300 to 125 psi (Figure 1). We wanted to know whether the PCM was commanding this, so we installed our scan tool, which allows us to see data and the pressure gauge at the same time. The data showed that the PCM was not commanding the oil-pressure oscillation, and since we noticed that both the desired pressure and the

PC-A amperage were steady at the time of the pressure oscillation, this led us to suspect a sticking PC-A solenoid.

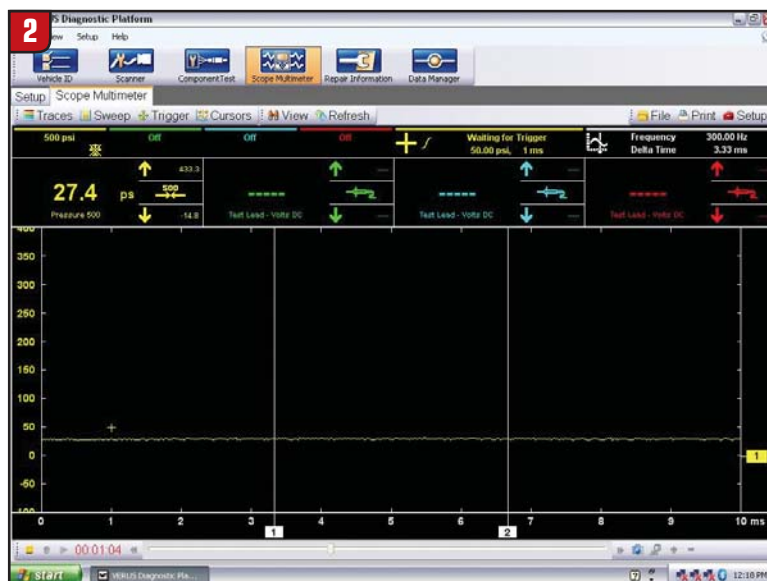
revved the engine in neutral and Park and noticed that when the engine speed started to come down the mainline pressure would drop to as low as 27 psi (**Figure 2**). This was more likely the cause of the neutralization feeling, since the mainline pressure dropped too low when the vehicle decelerated to a stop. So we removed the valve body and replaced the PC-A solenoid. The new pressure readings showed the problem to be corrected.

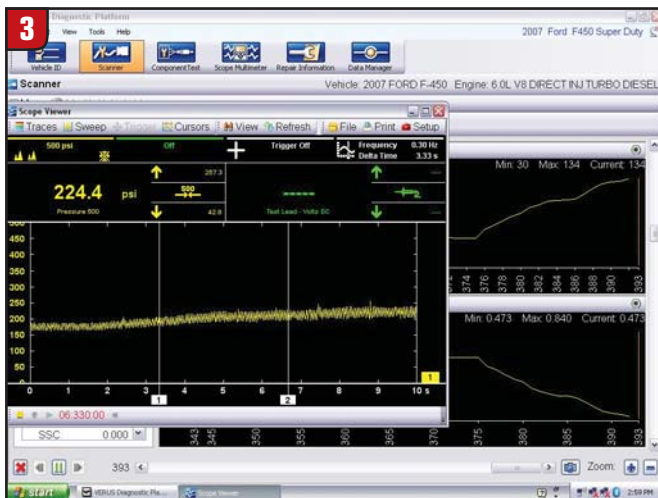
After replacing the PC-A solenoid we saw a steady pressure of about 225 psi and PC-A amperage around 0.47 in reverse at 1,500 rpm (**Figure 3**).

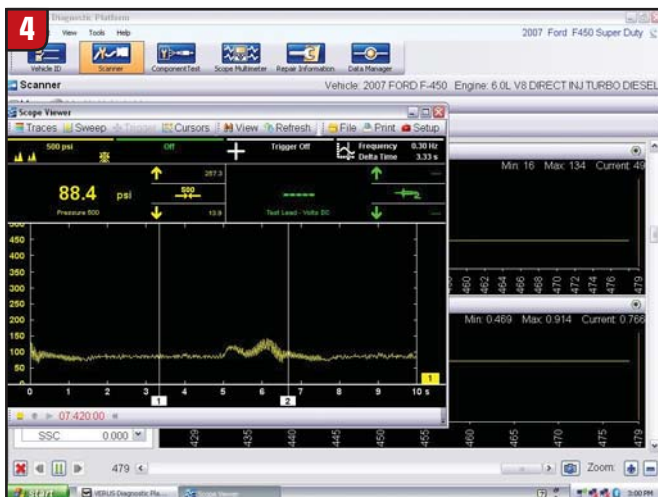
We noticed that the mainline pressure was now about 90 psi in drive instead of 50 and that when we revved the engine the pressure increased in proportion to engine speed, it was not oscillating and never dropped below 85 psi (**Figure 4**).
