# Shift Pointers

- **Author:** Jesse Zacarias
- **Subject Matter:** Diagnosis
- **Unit:** FNR5
- **Vehicle Application:** 2008 Ford Fusion
- **Issue:** TCC slip and/or code P0771

## FNR5

### TCC slip and/or shift solenoid E stuck off

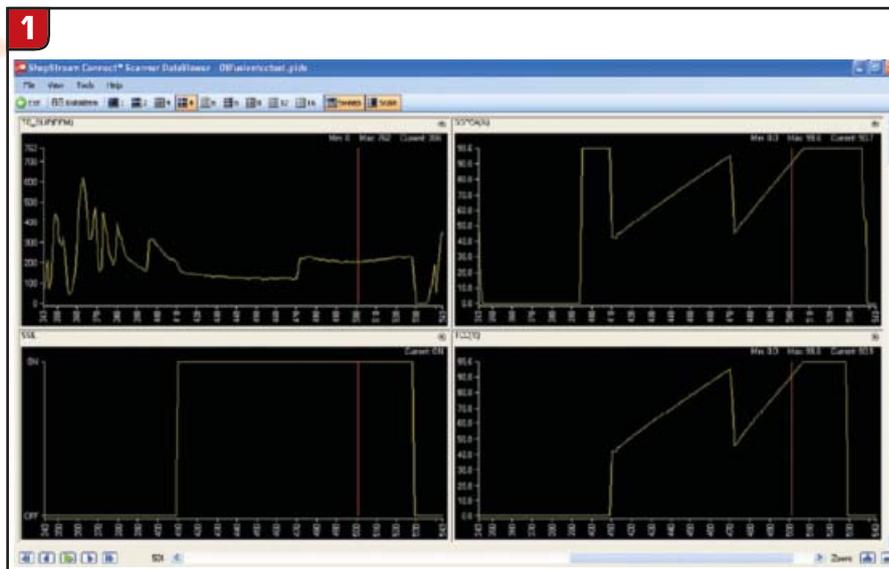
The FNR5 transmission can be found in most Ford and Mazda front-wheel-drive vehicles and has been with us for a while. One of the most-common calls we get on this transmission in the tech center at Valve Body Pro is for a code P0741 TCC slip and/or P0771 shift solenoid E stuck off. Recently we had a 2008 Ford Fusion with this problem. **Figure 1** shows the SSA (SSPCA) increasing the modulation but no drop in rpm slip.

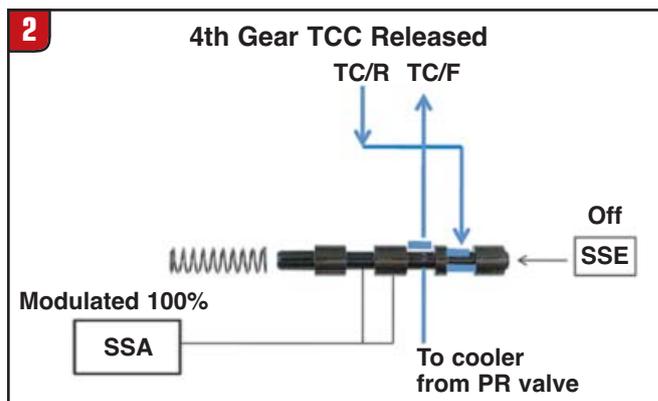
When the TCC is not engaged, fluid is present on both the front (TC/F) and rear (TC/R) of the torque-converter clutch, thus keeping the clutch from applying (**Figure 2**).

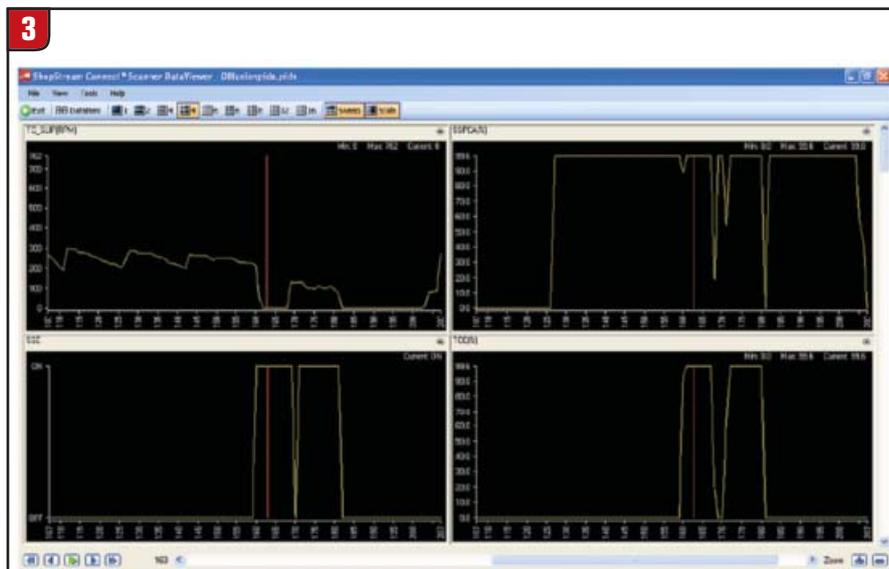
To apply the TCC in fourth gear, the SSE solenoid must be turned ON. The SSA solenoid, which is a PWM solenoid, is used to control the rate of apply. Since SSA is a normally open solenoid, when it is at 0% duty cycle it produces its maximum pressure, whereas at 100% duty cycle it produces 0 psi. If the TCC is to be applied directly without gradual application, the SSA will be ON 100% at the moment SSE is turned ON (**Figure 3**).

This ensures that no fluid will be present on the front side of the converter; that is, between the converter cover and the converter clutch.

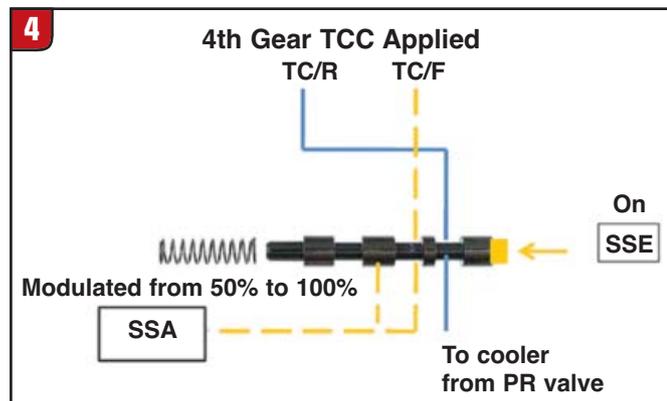
On the other hand, if the computer decides to apply the TCC gradually, SSA is modulated to about 50% when the SSE is turned

ON. This allows the SSA solenoid fluid to be present between the converter cover and the torque-converter clutch, thus not allowing the clutch to engage. As the SSA is gradually modulated to 100%, the fluid present between the converter cover and the converter clutch is eliminated to fully engage the TCC (Figure 4).

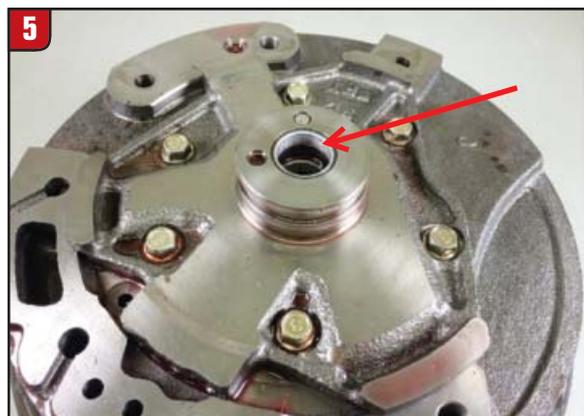
When rebuilding this unit you must look carefully for a worn-out valve-body bore at the TCC control valve and worn-out bushings at the pump stator on the location shown in Figure 5.

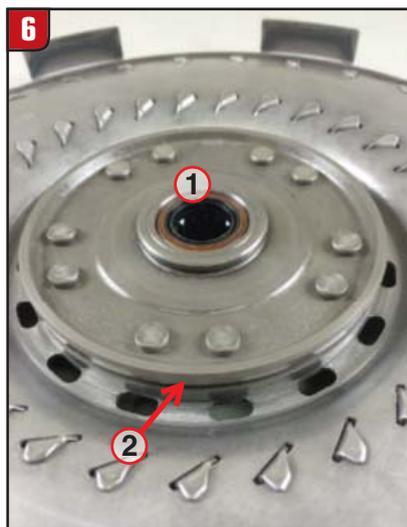
The other place that can cause the P0741 is inside the converter. Some of the most common, shown in Figure 6, are a damaged seal for the input shaft (1) and a worn or damaged sealing ring that seals the turbine and the clutch and damper cover (2). A leak from these

locations can allow fluid from the rear TCC to enter the front TCC and not allow the clutch to apply fully.
