Scan tool unable to communicate with PCM

4L80-E

1994 Chevrolet  
W4 Tiltmaster

# Do You Speak My Language?

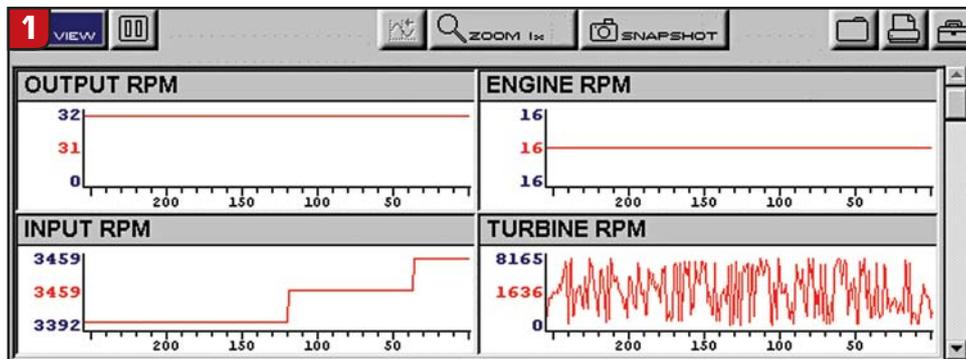
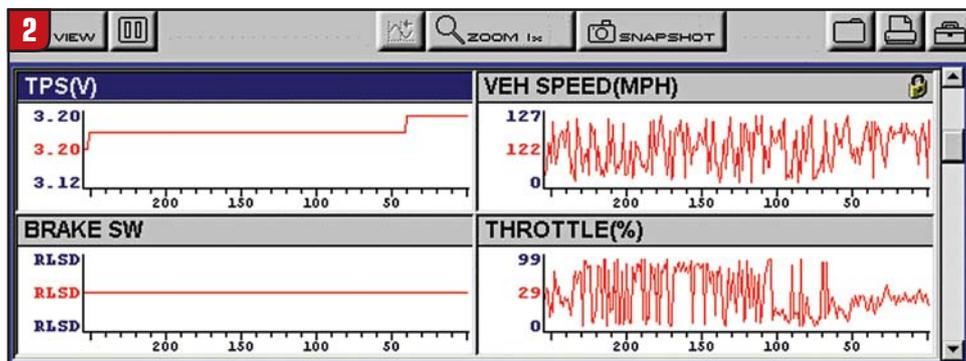
According to the data (see figures 1 and 2), at times we were exceeding 100 mph but our engine speed never exceeded 16 rpm. Our input and output speeds were definitely wrong. They showed output-shaft movement in park and erratic turbine speed. We can see now why the local transmission shop replaced all those parts. However, when we changed from monitoring transmission data to monitoring engine data, the engine-speed and throttle-percentage readings were correct. We thought, “Maybe it’s the scan tool.” So we got hold of another scan tool, Genisys, only to find the same readings.

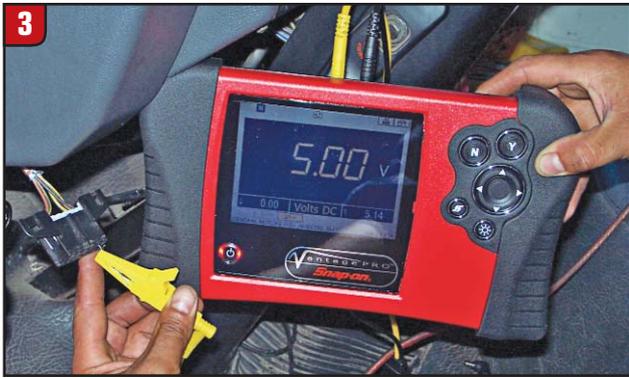
Since the factory scan tool was not able to obtain data for us, we decided to check for proper voltage at pin M of the data-link connector; this is where the data is fed to the scan tool. The factory manual calls for a 5-volt reading at pin M. We found no problems there (see Figure 3).

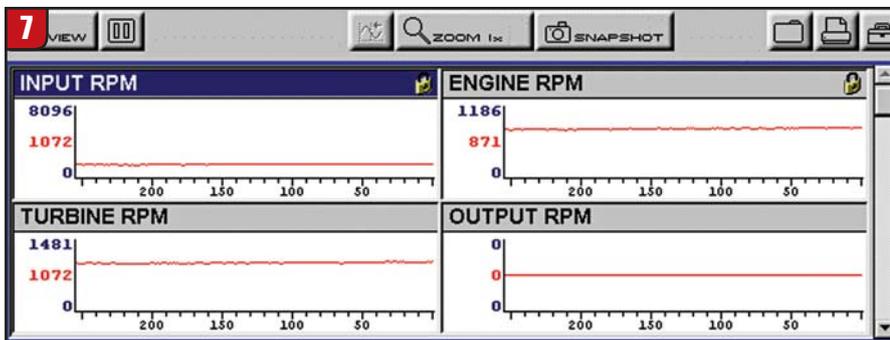
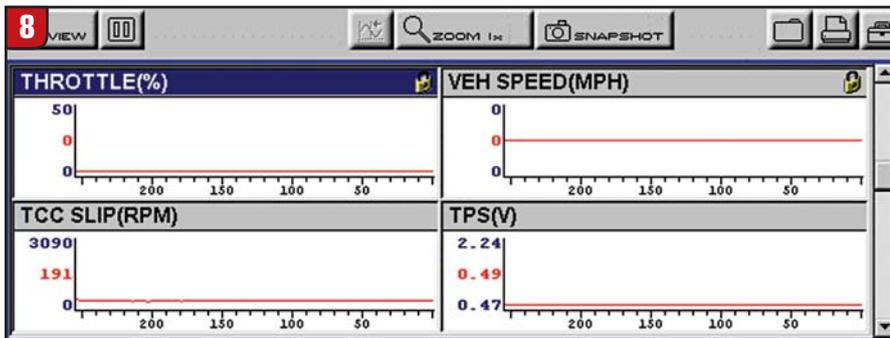
As you can see, our vehicle-speed reading was correct as well as our readings for the input- and output-speed sensors,

throttle-position sensor and throttle percentage (see figures 7 and 8).

By using the snapshot ability of the Snap-on SOLUS, we would now be able to check for TCC slip. We noticed that when TCC percentage was at 98% (which is too high), the TCC slip was 285 rpm (this should not exceed 100 rpm).

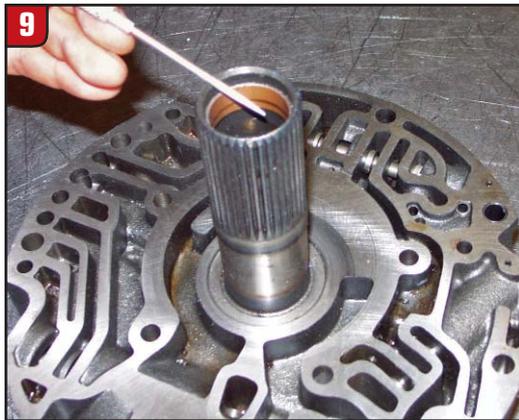
Everything seemed to be in order inside the transmission, but we noticed excessive wear at the stator bushing (see Figure 9).

We replaced the bushing and road-tested the vehicle, and the problem was corrected. TCC duty percentage was in the low 60s (as it should be) with practically no TCC slippage (see Figure 10).
