Poor performance caused by loose ground connection

09G

2003 Volkswagen
New Beetle

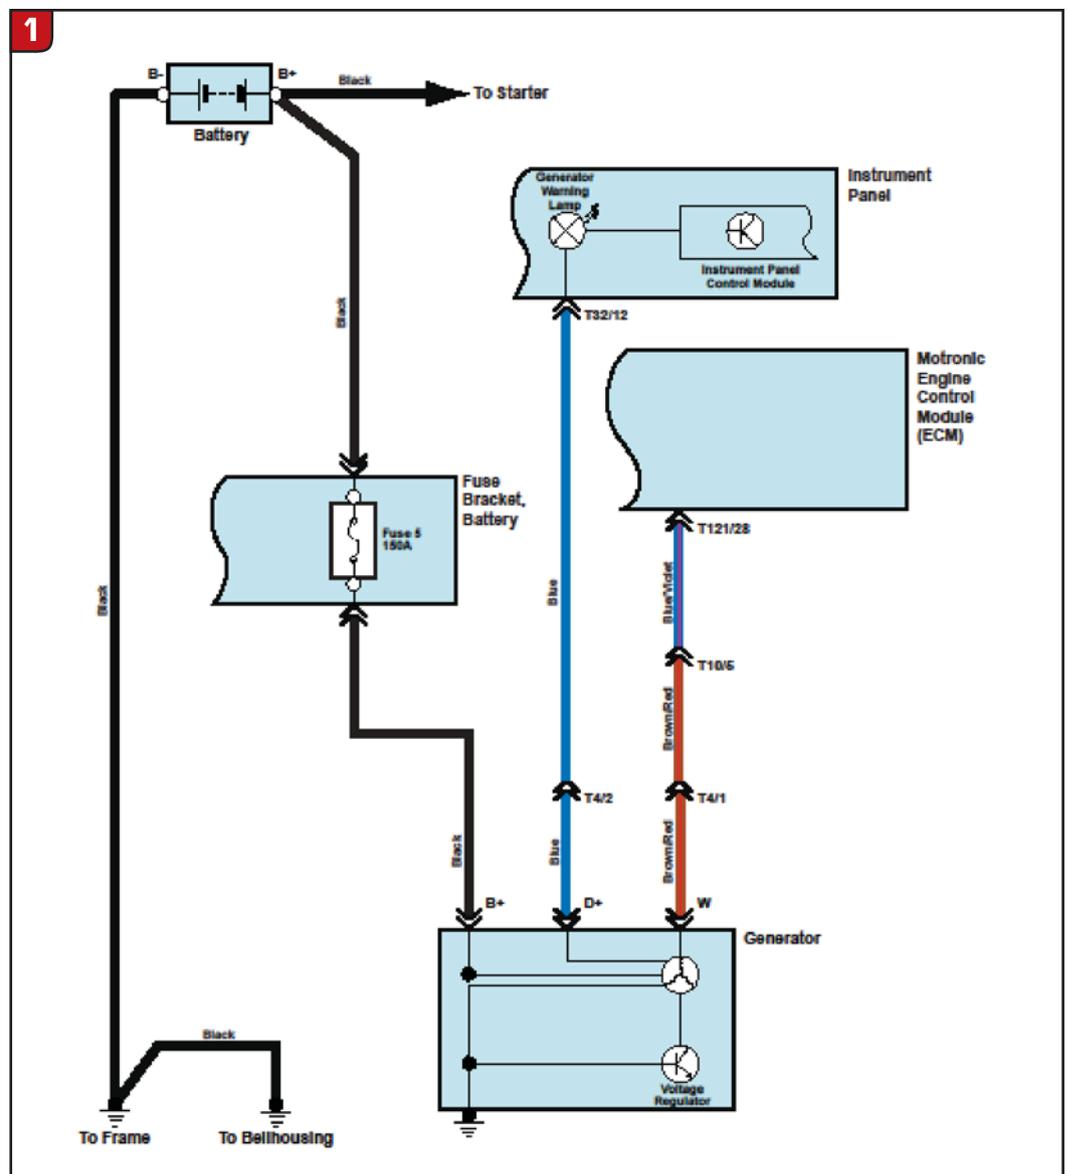
We installed our scope with Channel 1 (yellow) back-probing pin W at the generator (Figure 1). This is where the ECM controls the voltage regulator and would allow us to see the voltage regulator's performance and at the same time see the integrity of the circuit between connection W at the generator and pin #28 of the ECM. Channel 2 (green) was connected to the battery positive post. This is the best place to check for charging voltage (instead of at the back of generator B+), because you want to make sure the charge is getting to the battery and not just coming out of the generator. Finally, the scope was grounded at the battery ground so that all references were to battery ground, which would allow us to see the integrity of the ground (Figure 2).

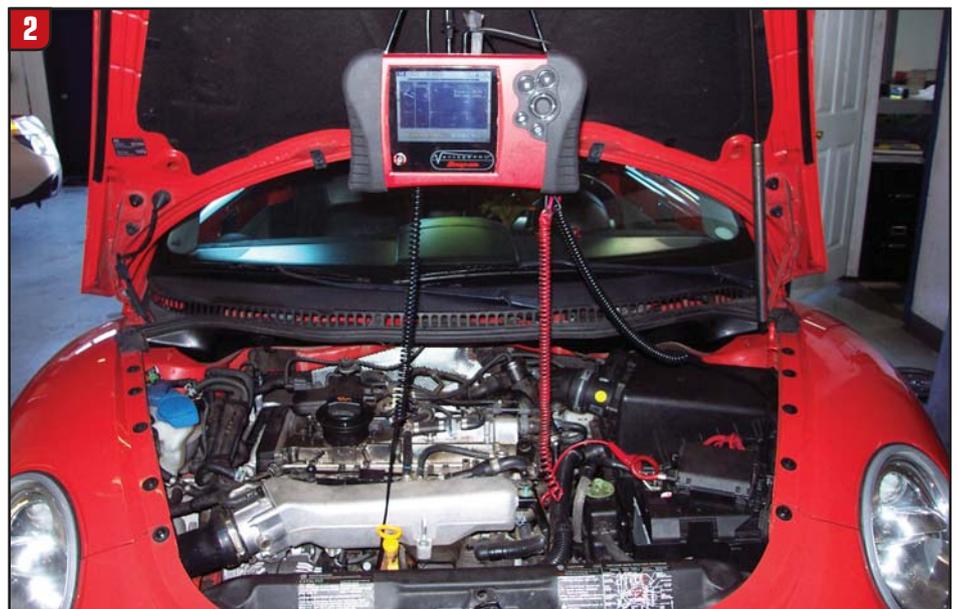
The scope showed a 320-mV drop on the ground side, but the charging voltage at the bat-

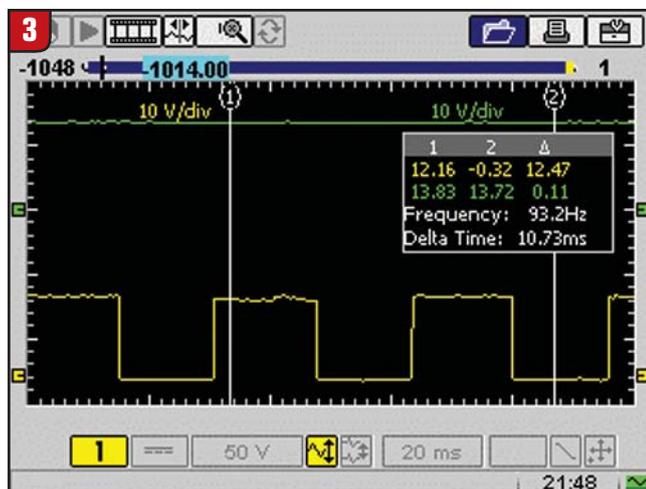
continued from page 12
 tery was 13.7 (Figure 3, cursor 2). An acceptable voltage drop between generator ground and battery ground should not exceed 200 mV; therefore, we immediately suspected a ground problem, but we decided to let the engine idle for a while.

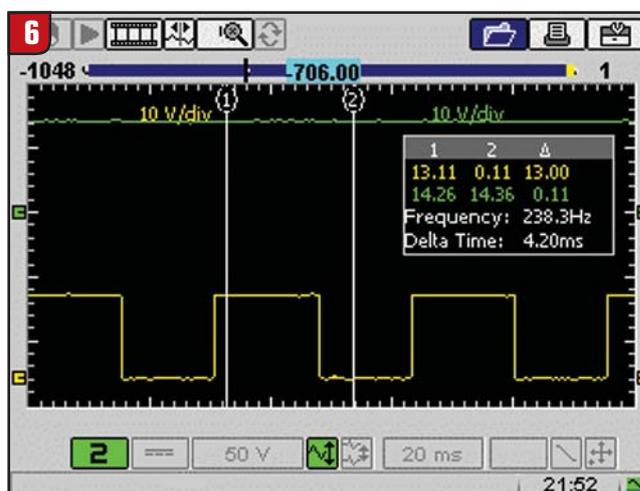
After we tightened the ground, the system returned to good working order and the ground never dropped below 110 mV under load (Figure 6, cursor 2).

This would explain the poor performance. With the faulty ground using up 2.64 volts, this left only about 11.5 volts available for the vehicle's electrical system. This was not enough voltage to make the injectors perform well, not to mention the poor performance of the fuel pump.
