Diagnosis of codes 41, 42 and 21

41TE

1995 Chrysler Cirrus

# Singing the TCM Blues

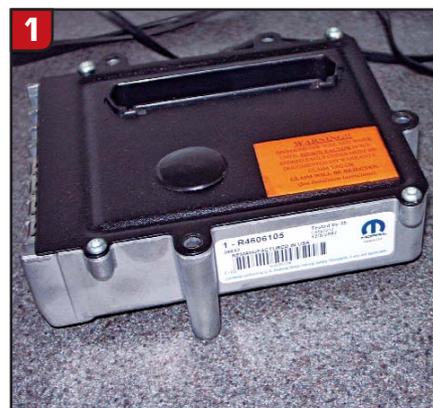
We released the vehicle, and within the month of the repair the vehicle came back with code 41. On the basis of the last diagnosis and the parts replaced, we decided to replace the TCM (Figure 1).

**Factory-remanufactured TCM**

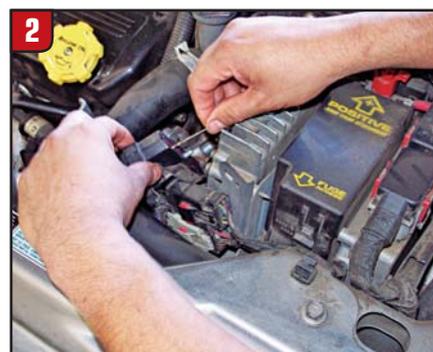
Two weeks later it came back with a code 41. We checked the harness connector at the TCM for a good contact by checking pin tension using a #53 drill bit (0.059) (Figure 2), and even though it passed we still decided to replace the #19 (2-4 solenoid) and #20 (L/R solenoid) wires at the TCM, soldering the wire connections rather than crimping them.

**Checking for proper connection between wire and TCM**

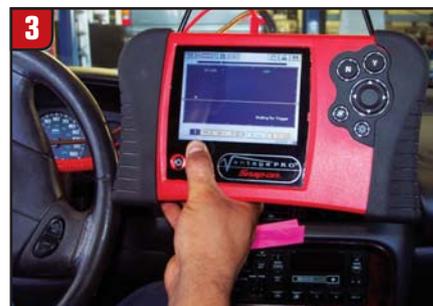
Two weeks later it came back with a code 41. This time we hooked up the scope, back-probing pin #20 (Figure 3).

**Back-probing pin #20 to check the L/R solenoid circuit**

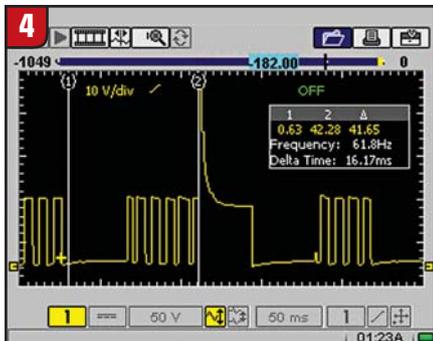
The problem was intermittent, so we had to drive the car for a while. The waveform showed a good voltage and ground (Figure 4). The TCM does a periodic sole-

**Cursor one shows a good ground (0.63v) and cursor 2 shows the spike at a level of 42.28 volts.**

noid-circuit resistance test. It does this by momentarily turning off the solenoid if it is on or turning it on momentarily if it is off, thus producing a voltage spike that should rise to a minimum voltage level. We could see the inductive spike present at a level we have known to be OK.

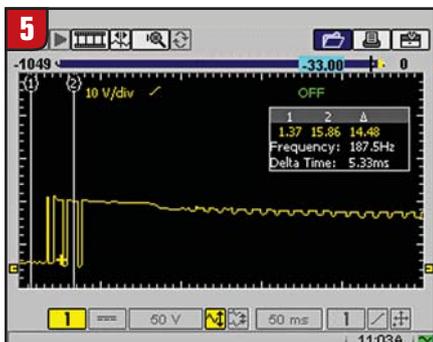
We were able to catch the problem as it happened (Figure 5), and

**The solenoid driver stopped modulating for no reason while the vehicle was in drive and idling.**

we concluded that the TCM was the problem even though it had been replaced.

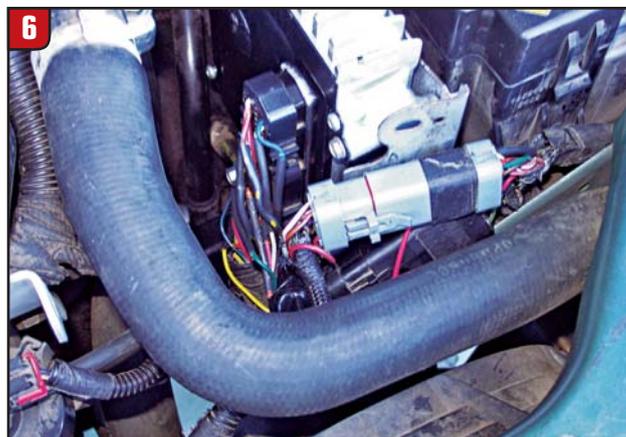
diagrams we noticed that the wiring harness from the solenoid body passes through connectors 104 and 105 before reaching the TCM (Figure 6).

**Connectors 104 and 105 in front of TCM**

To eliminate all possibilities (paranoia sets in) we bypassed connectors 104 and 105 by installing a new solenoid-body connector and a new TCM connector and wires. To eliminate any false connections we soldered all the wire connections and did not use butt connectors (Figure 7).

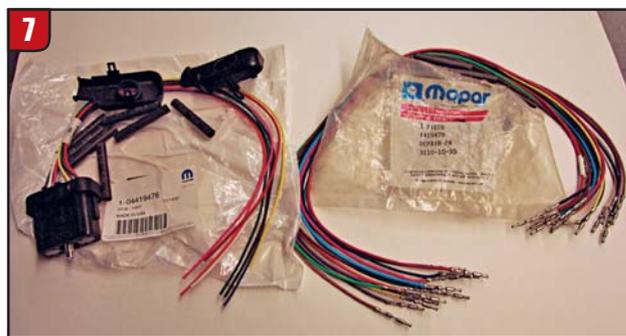
**Solenoid connector and TCM wire kit**

We now had new connectors at the TCM and solenoid body with new wires and had the solenoid body connected directly to the TCM, bypassing connectors 104 and 105.

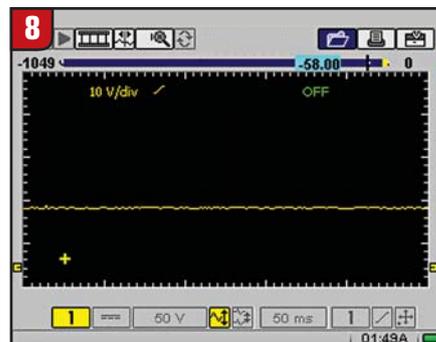
Within the week after we released the vehicle, it came back with code 42. We reconnected the scope, and again we could see a good voltage and ground and a good waveform. While driving the vehicle we were able to see the problem as it happened with the scope connected. This time while the solenoid was off, it failed the resistance test (figures 8 and 9).

**Solenoid in the off stage while the vehicle is being driven; voltage level 13.9v**

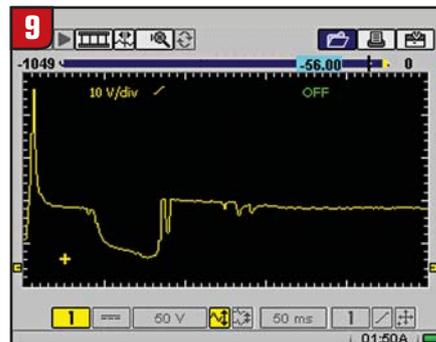
On the basis of the waveforms that we had seen right before the failure, all evidence pointed to a bad TCM. We called the dealer and were surprised to see that he was very cooperative and did not question us; he just sent another TCM (strange – no gauntlet?).

**The TCM performs a resistance test by turning on the solenoid momentarily. The solenoid driver failed and the TCM went into failsafe.**

We hooked up the scope and it showed a bad TCM. Enough is enough, so we ordered the fourth TCM from an aftermarket source, installed it, and the problem was solved.
