- Author: Jesse Zacarias
- Subject: Intermittent failure to upshift
- Unit: 722.6
- Vehicle Application: 1998 Mercedes M320

## Are We Listening?

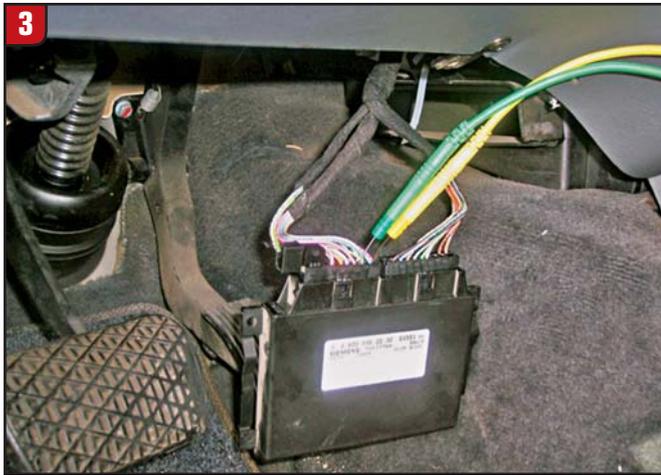
Testing N2 and N3 speed sensors in reference to battery ground

Since the codes were directing us to the N2 and N3 speed sensors again (notice no code 014), we decided to go straight to the horse's mouth, so to speak; we back-probed the N2 and N3 speed sensors at the TCM (Figure 3).

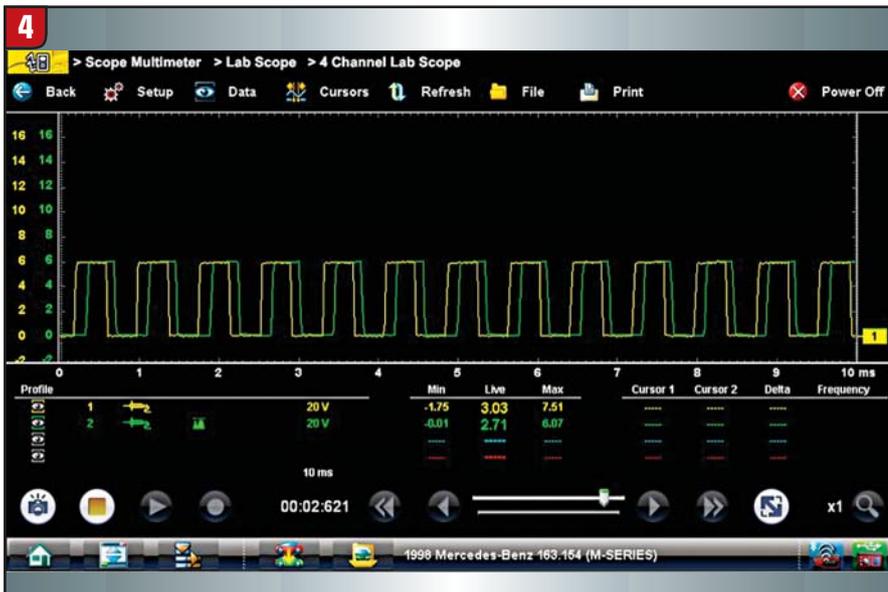
Channel 1 (yellow) is N2 speed-sensor signal and Channel 2 (green) is N3 speed-sensor signal in reference to battery ground. The problem was intermittent so we had to drive it for a while, but we finally got to see the problem. Figure 4 shows a good signal from both N2 and N3 speed sensors. Remember that both speed sensors share a common 6 volts and ground provided by the TCM. Each speed sensor has its own signal return wire to the TCM. Grounding the scope to battery ground (reference to battery ground) allows us to see the voltage and ground integrity of the circuit in one test. Here we can see good voltage source (6 volts) and a good ground (0 volt), and the frequency (Hz) changed with increase in road speed.

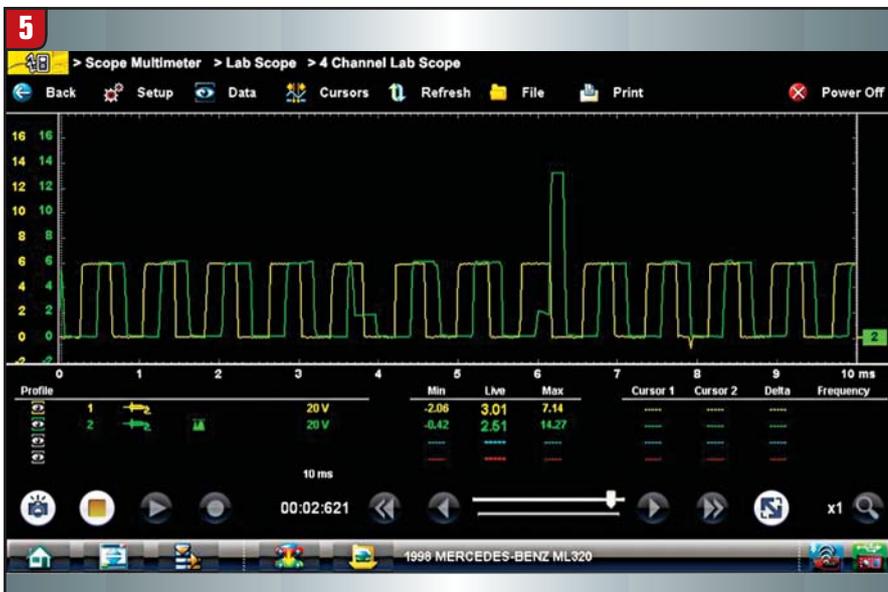
However, every now and then we saw a short to voltage on the N3 speed-sensor return signal (Figure 5).

Now the most-likely short in the circuit to battery voltage would be the voltage that the TCM provides to the transmission through pin 6 for the shift solenoids, and since this was an intermittent problem we had to make an educated guess. We know how problematic the transmission-harness connector can be, so we decided to start there. Our hunch paid off (Figure 6).

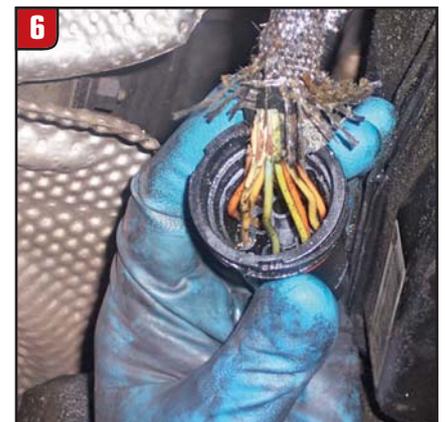
It appears that the connector did leak transmission fluid into the harness, but it did not get to the TCM. The fluid had caused the insulation to flake off at the bot-

tom of the “U” portion of the bend in the harness. This harness is part of the main vehicle harness and the cost would be more than this student could pay, so we decided to cut each wire individually and then install heat-shrink tubing on the damaged part of the wire before reconnecting the wire halves and then shrink the tubing to ensure good seal and insulation.

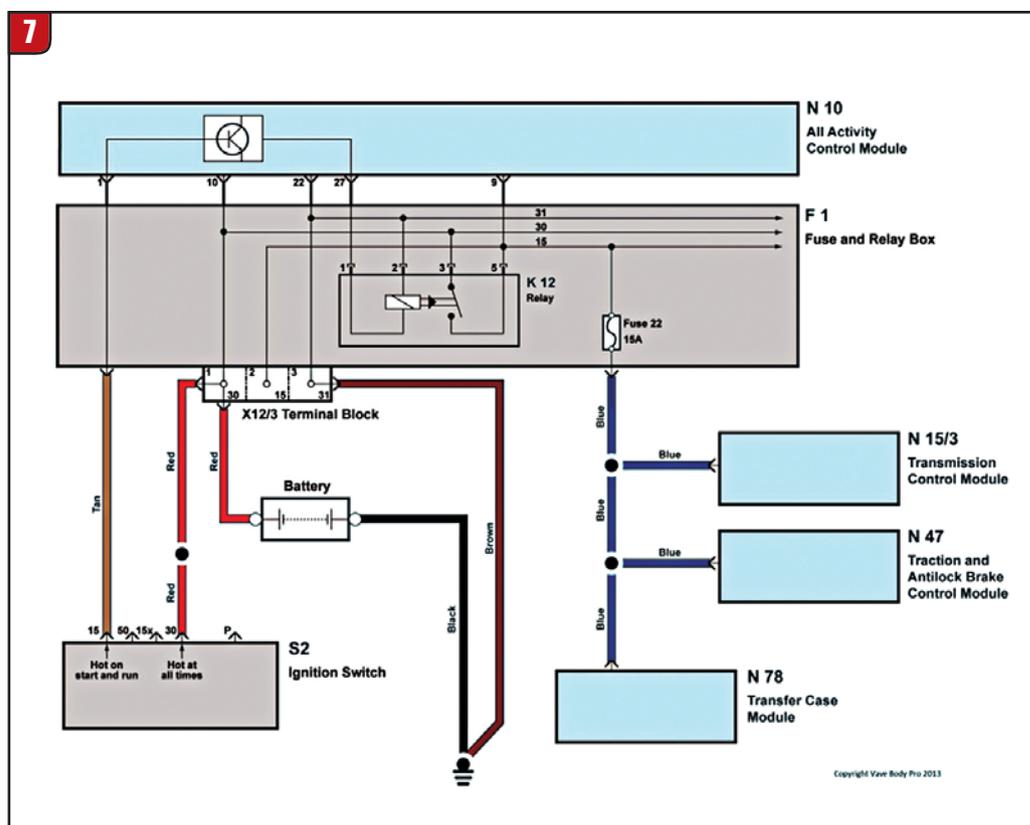
A close look at the wiring diagram (Figure 7) led us to suspect the K12 relay, and after more voltage-drop checks we found relay K12 to be defective. The relay would fail at times to turn on and supply voltage to circuit 15, which feeds fuse F22, which in turn provides voltage to the transmission control module (N15/3), transfer-case module (N78) and ABS module (N47). With these modules not turned on, no speed-sensor information was provided to the TCM, so the transmission would not shift.
