Abrupt downshift and upshift

RE4F04A

Vehicle Applications:Mercury Villager,
Nissan Quest**Essential Reading:**

Taking the Long Road

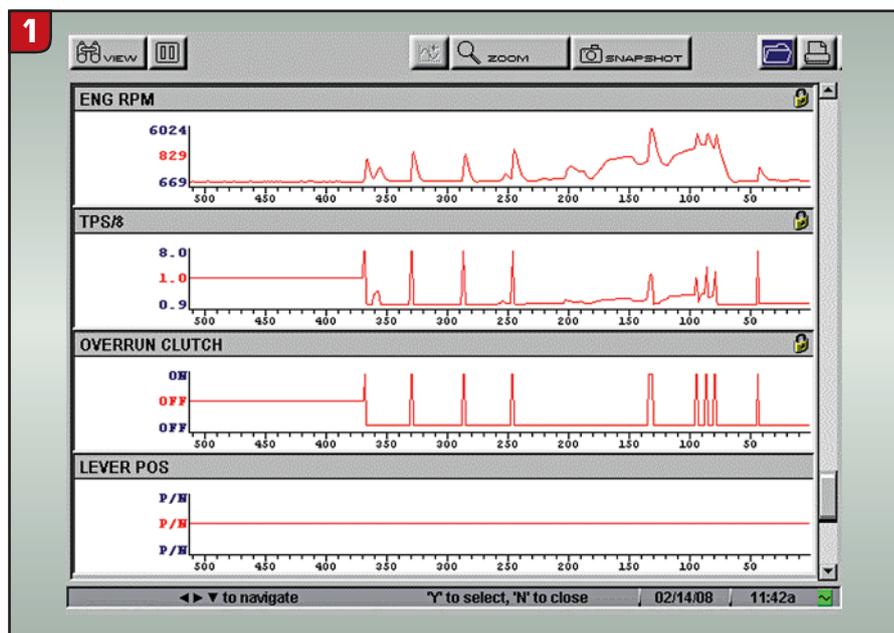
second positions. All the other lever positions read fine. We also noticed that when we accelerated with the lever in Park, the overrun-clutch parameter went from off to on after the accelerator passed the halfway point (2.2V) (see Figure 1).

Vehicle is in Park and accelerator pedal is gradually pressed. As the overrun-clutch parameter reaches 2.2V the overrun-clutch solenoid is turned on (see frames 135 through 80 of TPS and overrun clutch).

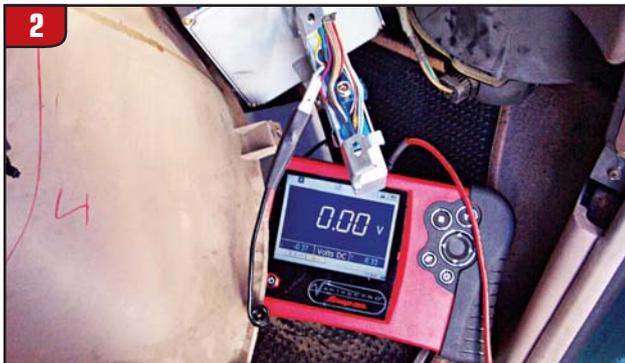
Lever position in Drive – pin 34 should read battery voltage.

voltage at pin 27 (manual 2nd) and 34 (drive) (see Figure 2), which are inputs from the inhibitor switch, but all the other TCM inputs seemed normal. The inhibitor switch sends battery voltage to the TCM depending on the gear selected through pins 26, 27, 34, 36 and 35. If voltage fails to get to the TCM when the lever position is changed, then the TCM shows the last signal received (in this case neutral).

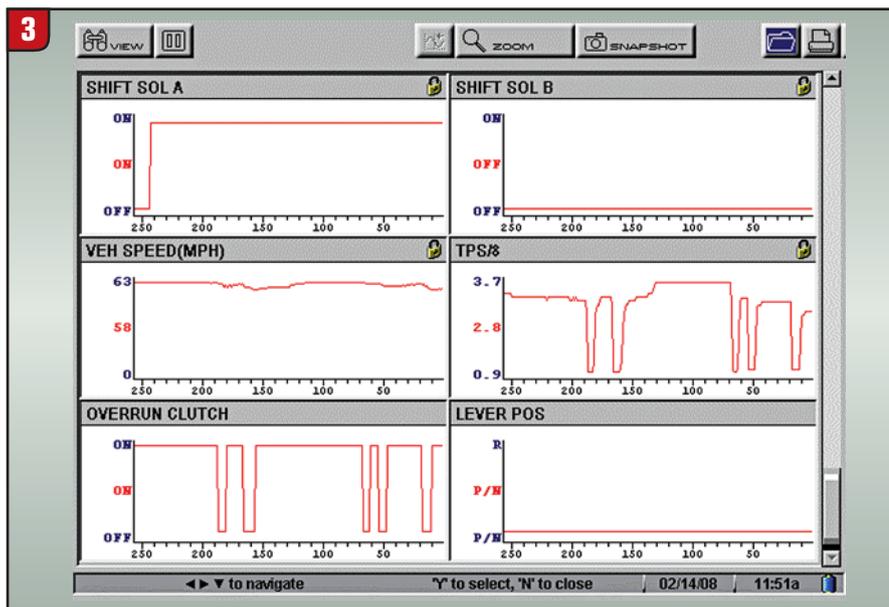
The inhibitor switch was failing in both the Drive and second-gear-select positions (open voltage). This meant that as we were driving, the TCM thought the vehicle was in Park or neutral, as that was the last signal received. As a result, the TCM turned off the overrun-clutch solenoid, thus engaging the overrun clutch, which in itself is no problem; however, when the vehicle reached about 60 mph (about half throttle in the TPS), the TCM would turn the overrun-clutch solenoid on, thus disengaging the overrun clutch. This meant that when we accelerated, the overrun-clutch solenoid was turned on, and when we decelerated, the overrun-clutch solenoid was turned off (see Figure 3). This was causing the feeling of an abrupt deceleration and acceleration.

Notice that after 60 mph the overrun-clutch solenoid is turned off and on in accordance with acceleration and deceleration, and the inhibitor switch shows the vehicle in Park or neutral.

So here's what was going on: When we accelerated the vehicle, the TCM was shifting the transmission into overdrive and turning on the overrun-clutch solenoid, thus achieving fourth gear. When we decelerated, the TCM was turning off the overrun-clutch solenoid, thus applying the overrun clutch while the overrun-clutch control valve was downshifting the transmission to third; this caused the abrupt feeling.

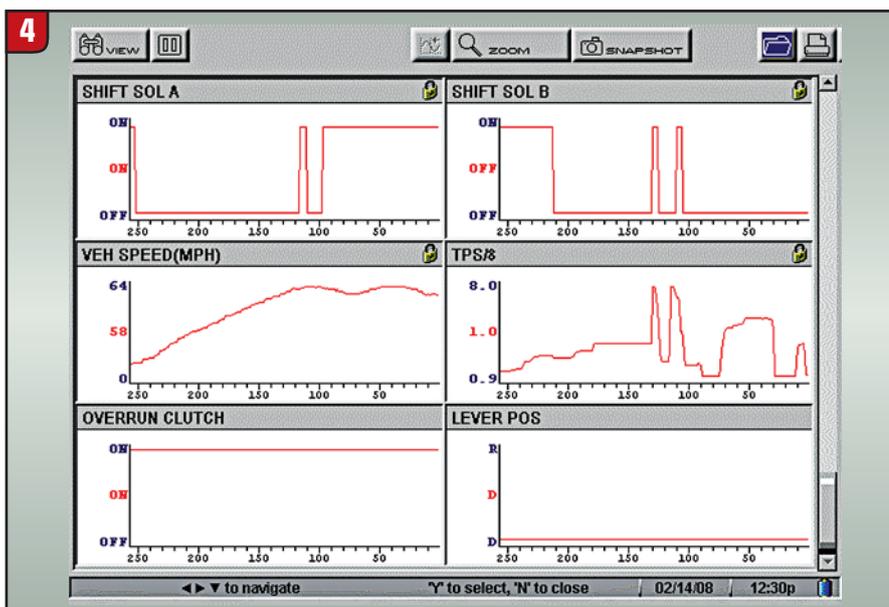
Notice that the overrun clutch is not affected by TPS fluctuation.

After we replaced the inhibitor switch, normal operation of the overrun-clutch solenoid returned in Drive during acceleration and deceleration, making the TPS signal voltage go from low to high as shown in Figure 4.
