Transmission malfunction caused by defective tow-package wiring

2000 Toyota Tacoma

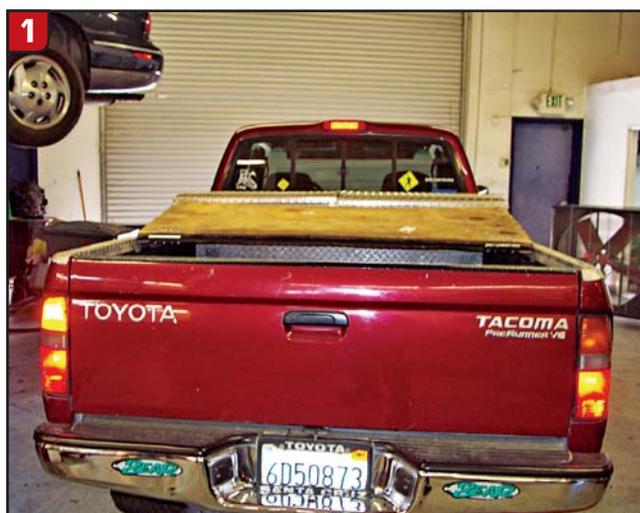
We checked for codes and noticed a P0755, shift solenoid B malfunction. On observation we noticed that when the left turn signal was turned on the brake lights came on (see Figure 1)

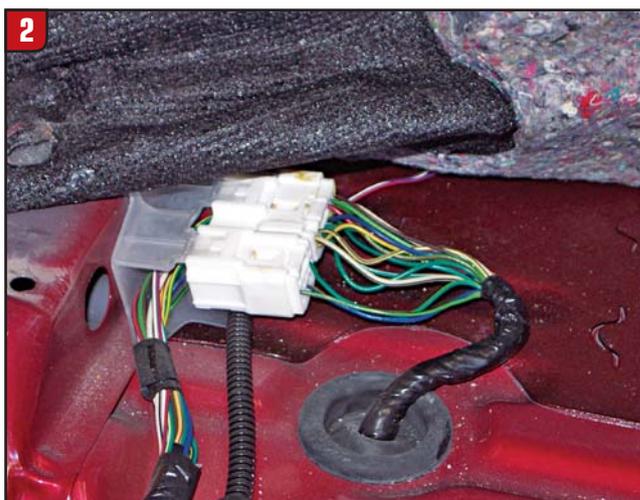
We studied the factory wiring diagram and noticed that other than the ground, the only connector that both the turn signal and stop light had in common was the BN1 connector under the driver's

seat. So we removed the seat to inspect the connector but found no sign of corrosion or anything else wrong, for that matter (see Figure 2).

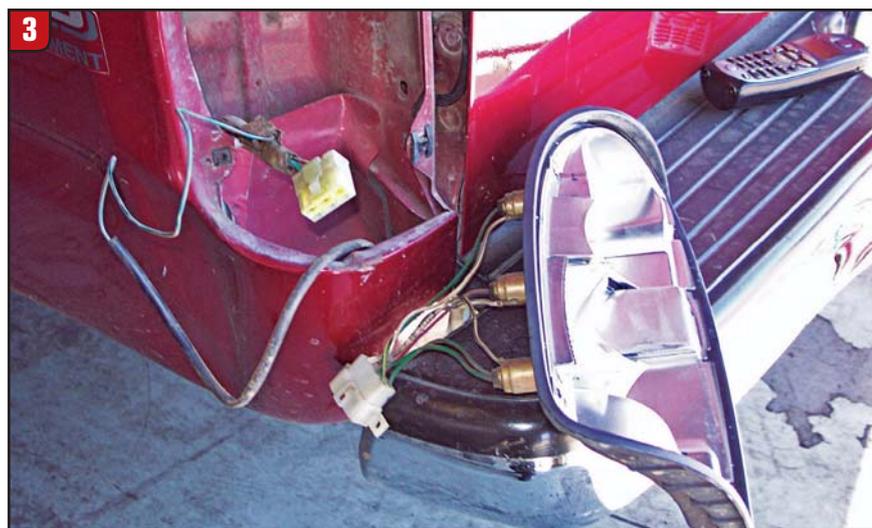
Next we inspected the left-rear light assembly and removed it from the system (see Figure 3), but

the problem was still there.

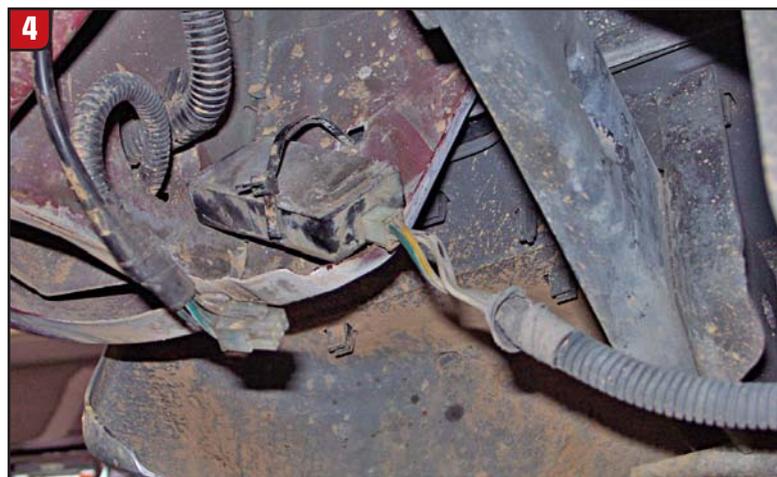
We started to inspect the bottom of the bumper for any sign of wire damage to the harness when we noticed what appeared to be an aftermarket tow package (see Figure 4). When we disconnected the box the problem went away.

The notice, "SSC-10H Trailer Towing wire harness converter safety recall," covers 2000 Toyota Tundra and 1999-2000 Toyota Tacoma. According to the recall the "harness converter" (see Figure 4) can short out or cause an open circuit.
