- Author: Jesse Zacarias
- Subject: Harsh Drive engagement
- Unit: AW55-50SN
- Vehicle Application: Volvo

# The Importance of Proper Testing

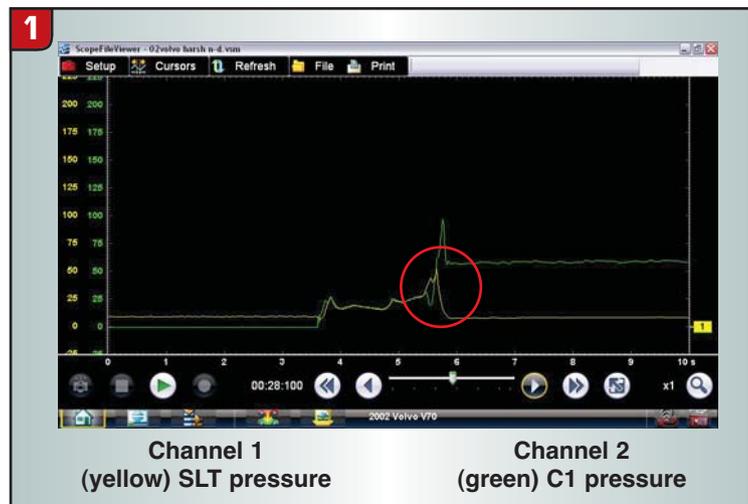
As soon as we saw the C1 pressure graph we knew something was wrong in the C1-clutch drum circuit (Figure 1). There was a sudden drop of about 20 psi at the end of the torque phase just before the inertia phase, and the torque phase was not a smooth rise as we expect to see.

The reason the pressures during the torque phase of the readings with the bad piston were not rising smoothly (Figure 1) is that the TCM was not seeing the turbine-speed sensor drop during the torque phase of the application because of the dragging piston. This caused the TCM to increase the SLT pressure and, thus, the C1 apply pressure. With the piston replaced, both the SLT and C1 pressure rises were smooth during the torque phase (Figure 3). **TD**

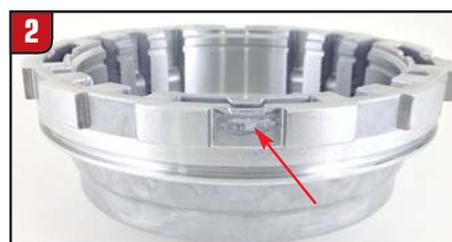
This test procedure reminds us of the importance of using regulated air when air-testing the drums at the bench. If we test them with unregulated shop air pressure it may apply well, but that is not how the clutches are applied in the real world. After carefully inspecting the C1 piston they noticed that it was dragging on the drum (Figure 2).

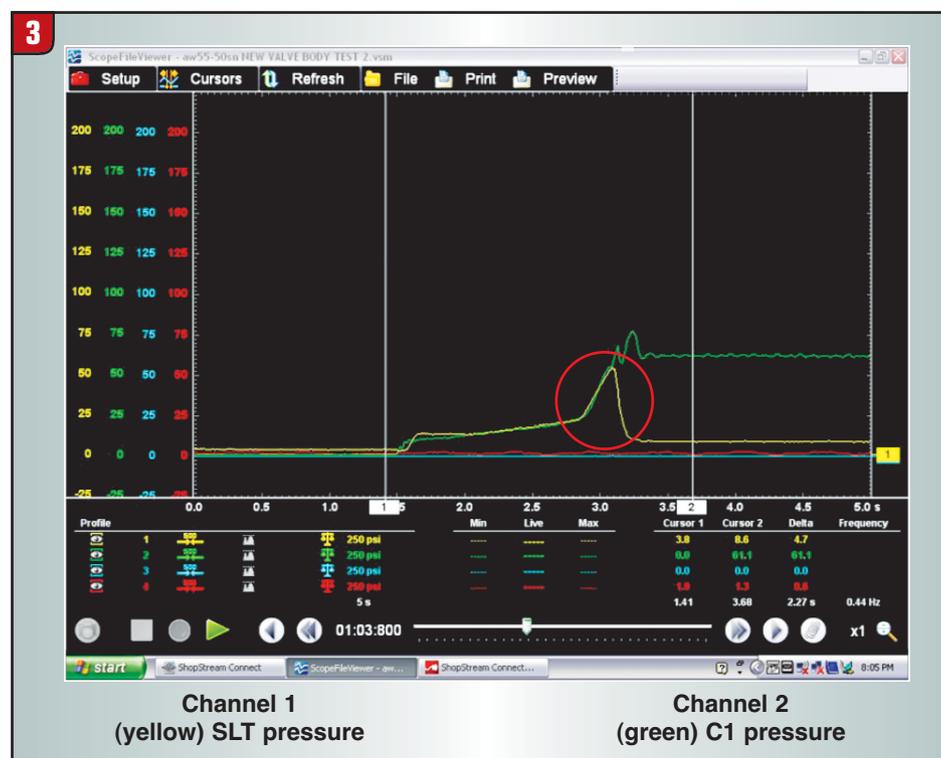
After replacement of the piston, the neutral-to-drive engagement was very smooth (Figure 3).

not show the three phases in a way we can see. SLT pressure is what controls the apply stages of the C1 clutches. When Drive is selected, main line pressure is directed first to the C1 control valve, where the C1 apply is controlled by the SLT solenoid (Figure 5). During the torque phase you can see SLT pressure and C1 apply pressure equal in Figure 3.

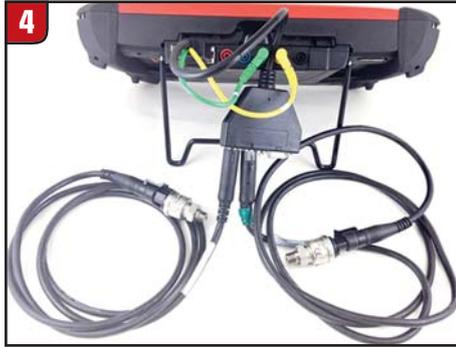
Now all this brings us back to the need for using proper testing procedures and equipment. This problem would have never been found without the use of pressure transducers (Figure 4).

Two pressure transducers connected to a dual-channel graphing meter
