Delayed engagement in reverse, neutralizing during deceleration

5R110W TorqShift

2007 Ford F-450 with 6.0 diesel

# What We Do for a Buck

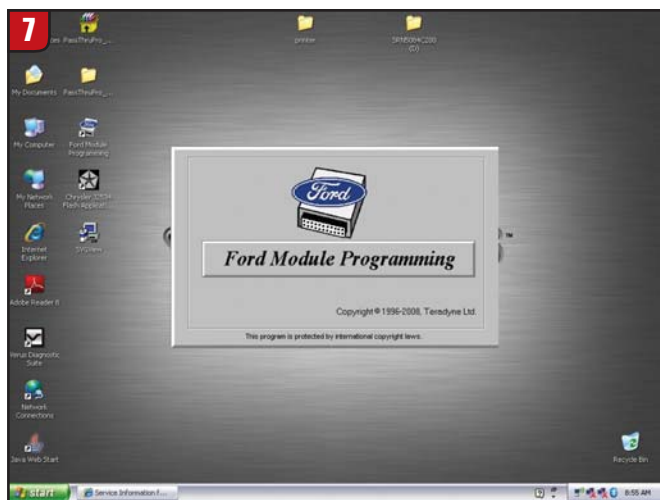
new PCM software updates if they are available (figures 8 and 9).
